**DOT/FAA/AR-00/44**

# **Impact Damage Characterization and Damage Tolerance of Composite Sandwich Airframe Structures**

January 2001

Final Report

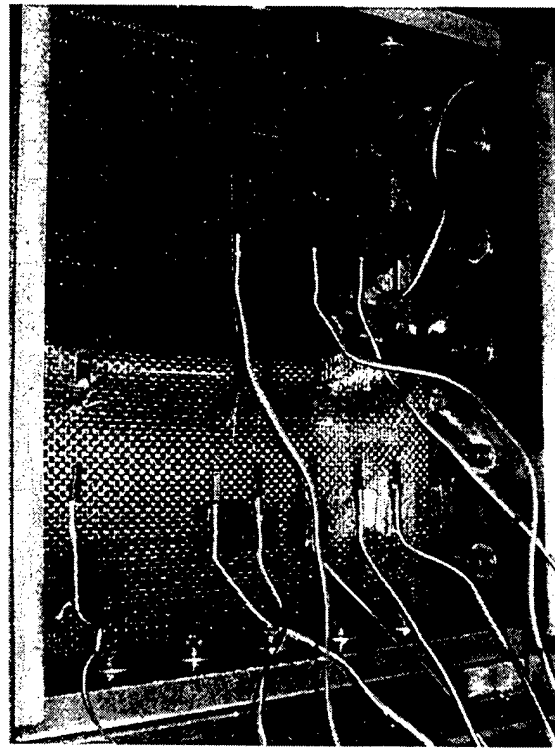
FIGURE 74c. BACKSIDE OF THE PANEL  
(WXC29L) AFTER FAILURE

The pictures of the specimen in figures 74a to 74c show the typical failure mode associated with panels impacted with the large impactor. The local buckling of the skin across the width of the panel is shown in figure 74b.

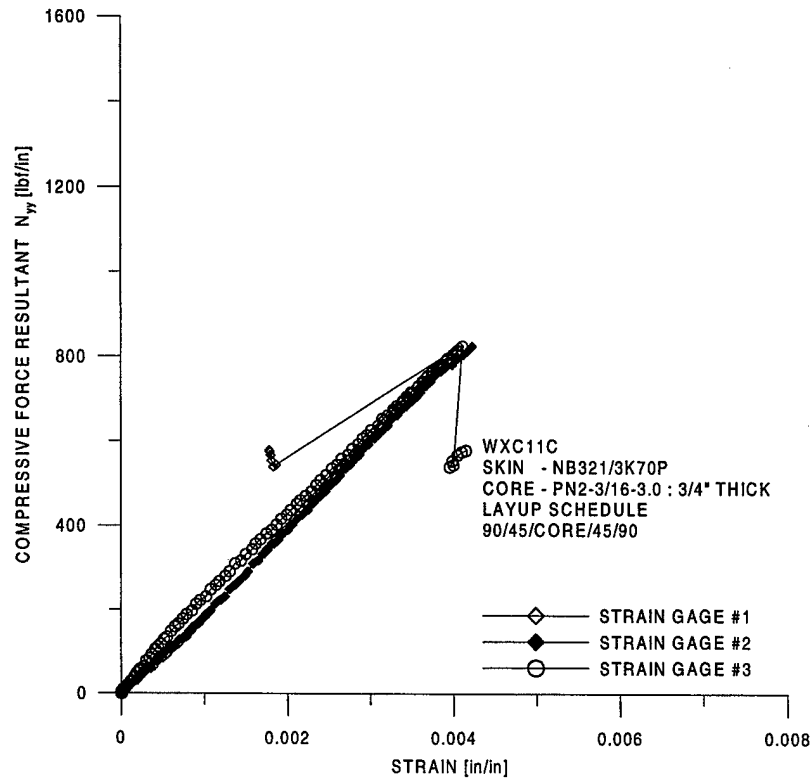
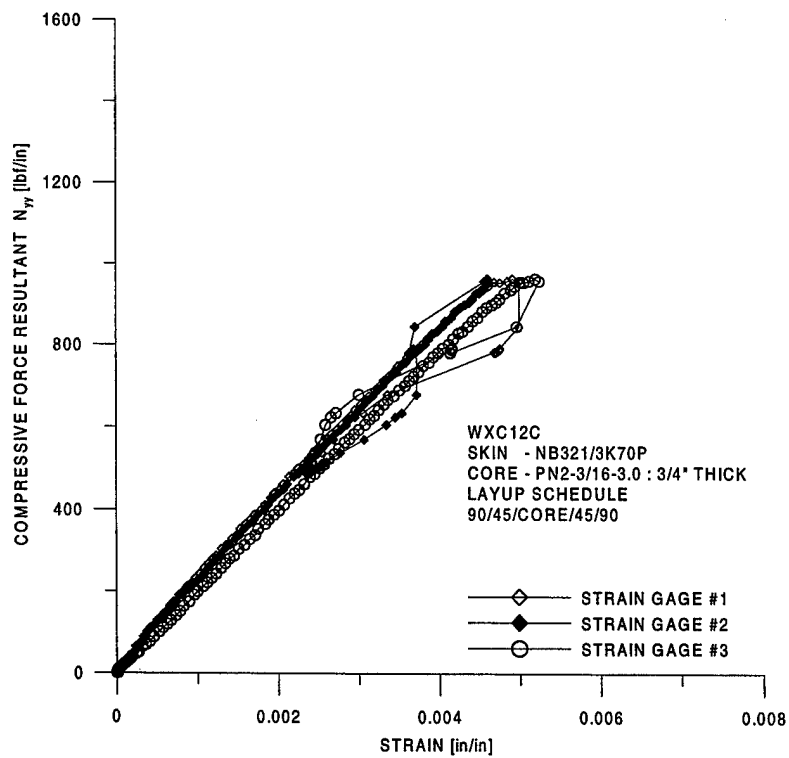
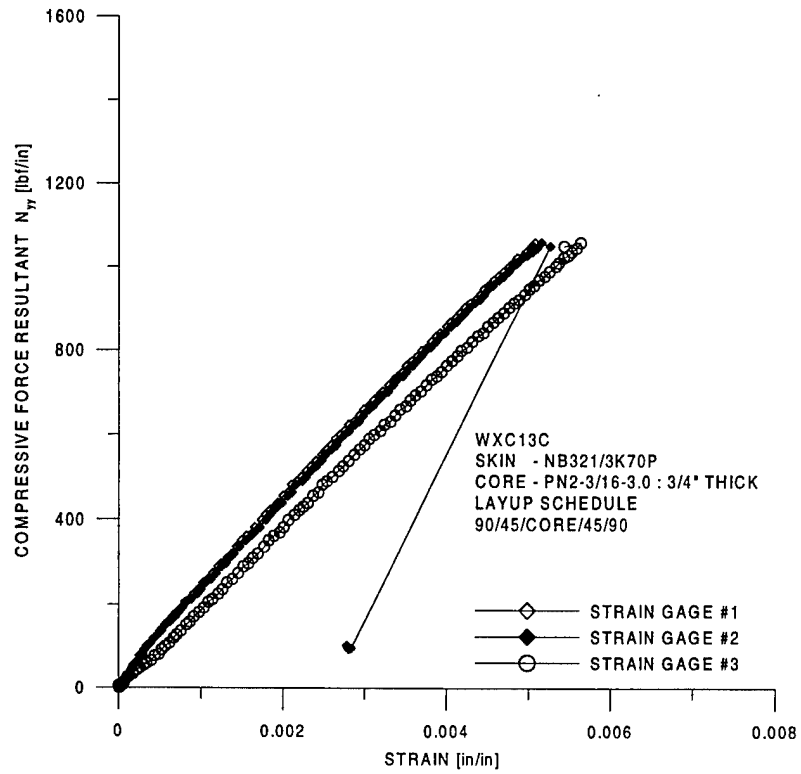
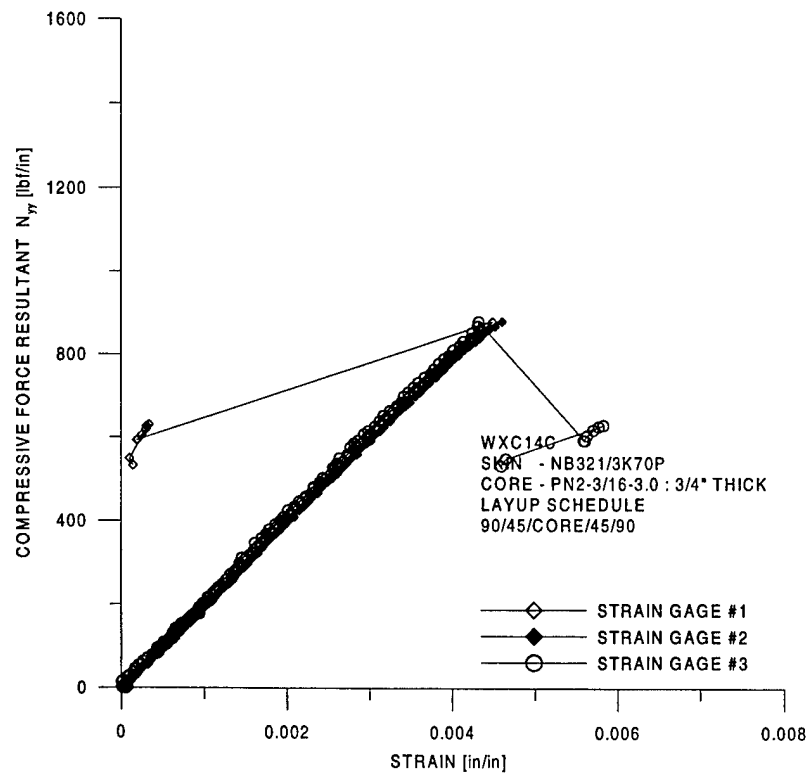
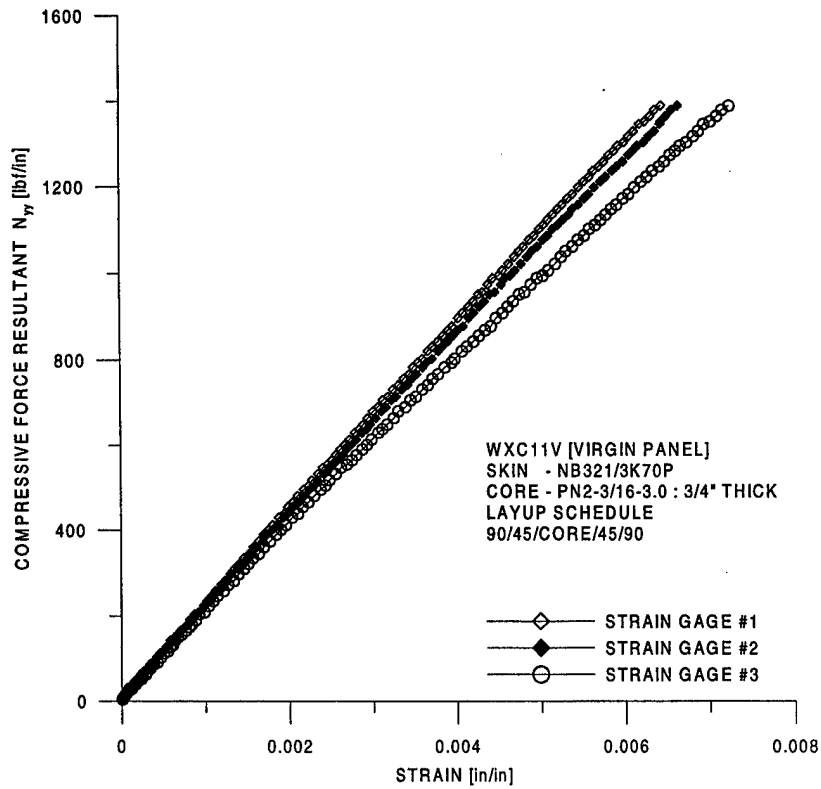
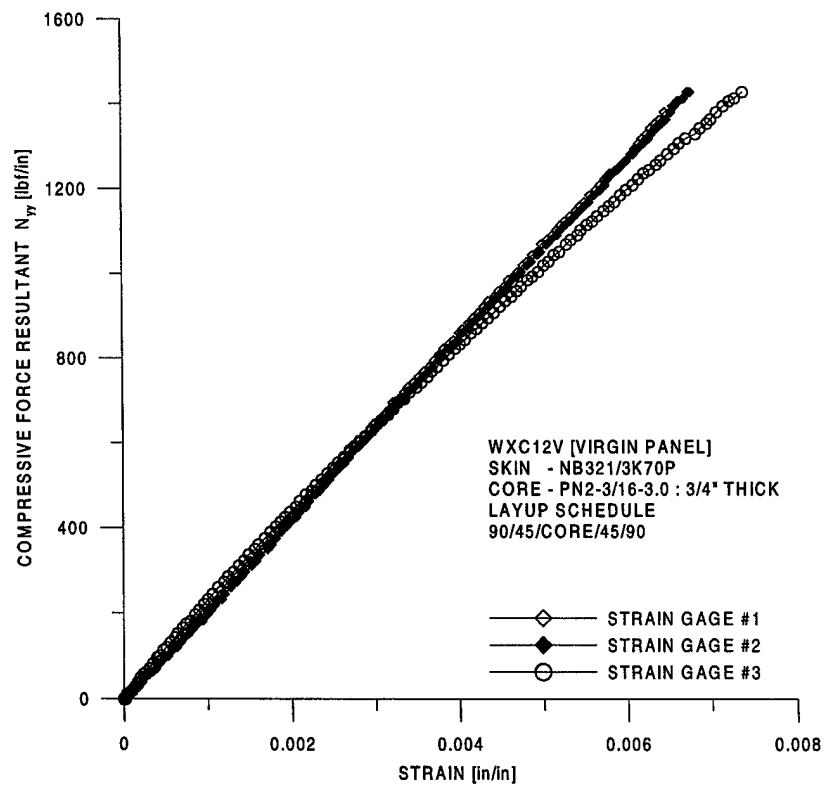
# APPENDIX D—FORCE RESULTANT VERSUS STRAIN GAGE RENDERING PLOTS
